Evaluating Road Resilience to Wildfires: Case Studies of Camp and Carr Fires

December 2023

¹University of California Pavement Research Center, Department of Civil and Environmental Engineering, UC Davis

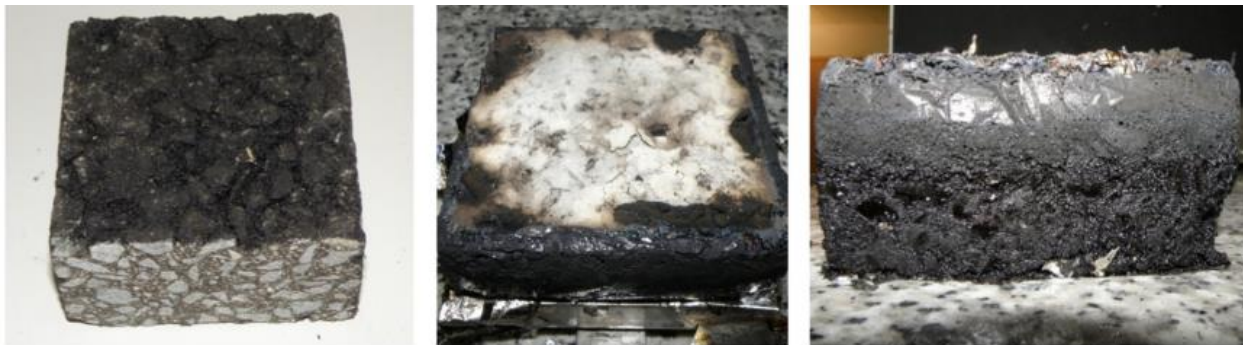
Figure 1. Pictures of asphalt pavement before and after a fire experiment from (Puente et al., 2016)

A study modeled the temperature conditions along the roadway during the Camp Fire. The predicted temperature increase ranged from 7°C to 297°C five hours after ignition, depending on the conditions of the fuel and roadside vegetation (Barzegar and Wen 2023). Based on these temperature changes and the asphalt binder's flammability is around 300°C (572°F) (Zhu et al., 2021), asphalt pavements are usually not prone to burning during wildfires. Nevertheless, ignition can occur if combustible materials such as trees and vegetation, oil and flammable fuel, and vehicle gases catch fire on the pavement, generating high-temperature fire. In such cases, the damage is generally confined to the area of the abandoned burning object, leading to localized surface scarring, thermal degradation of the asphalt pavement, such as detachment of aggregate as the binder is consumed, and thermal deformability, mainly based on experimental studies of tunnel pavements in fire (Puente et al., 2016; Toraldo, 2013). Images of an asphalt pavement before and after exposure to a localized fire are shown in Figure 1 from a study by Puente et al. (2016). However, widespread damage can result from the intense heat in wildfire-stricken areas, causing the asphalt to soften and deform or crack under the weight of heavy fire trucks and emergency traffic (Peker, 2021).

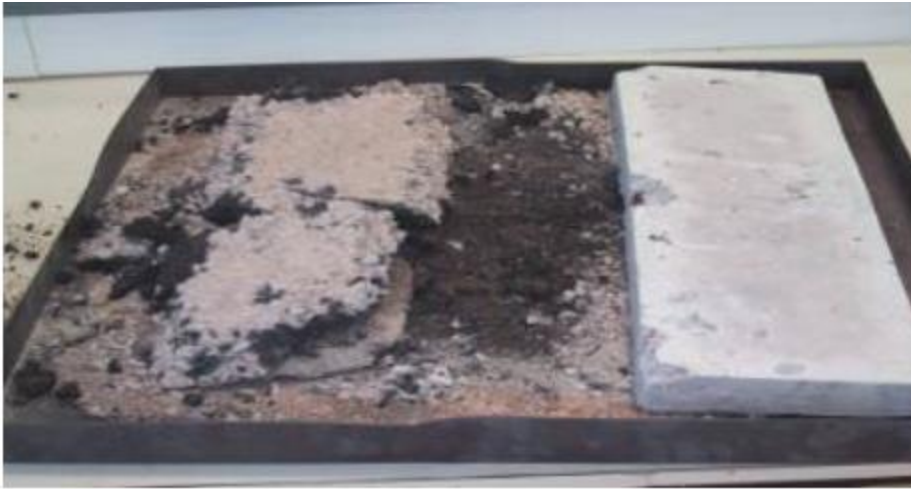
Figure 2. Asphalt (left) and concrete (right) exposed to 750°C (1382°F) heating experiment from (Rimac et al., 2014)

In the case of rigid pavements, concrete is a non-combustible material, does not usually burn during fires, and is considered to have a higher thermal load resistance than asphalt pavements (Toraldo, 2013). See comparison pictures of asphalt and concrete specimens during a fire test in Figure 2.

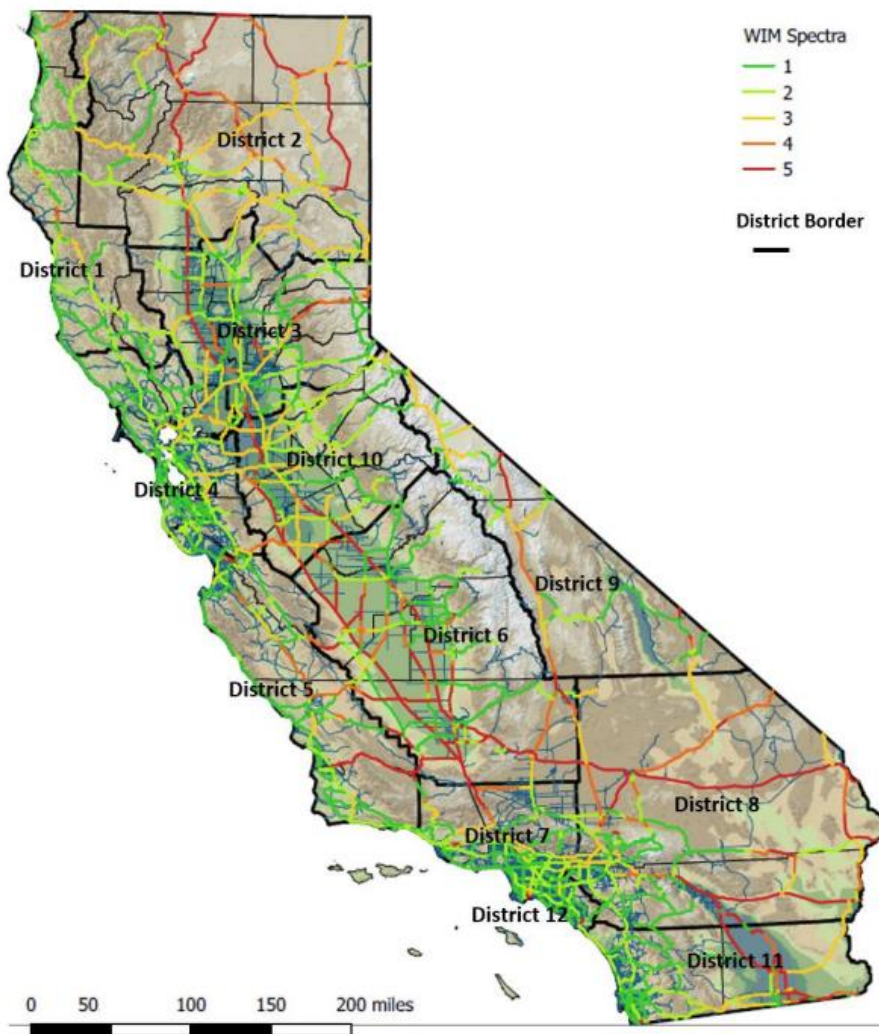
Figure 12. Designated WIM spectra to each segment of the Caltrans highway network

loads. The amount of each distress, such as cracking, is calculated from the total damage. Caltrans operates 132 Weigh-in-Motion (WIM) stations at key highway locations. These WIM stations collect, process, and store data on truck traffic—including truck classifications, speeds, gross vehicle weights (GVWs), and axle loads (Caltrans(a), n.d.). The University of California Pavement Research Center (UCPRC) periodically obtains these data to update the axle load spectra used in the Caltrans pavement management system’s performance models and Caltrans’s concrete and asphalt pavement project-level simulation and design programs. To generate traffic inputs for pavement design and pavement management, in 2018, the UCPRC took axle load distributions from all the WIM stations for the 11 years from 2004 to 2015 and grouped the axle load spectra into five representative spectra. Of these five representative spectra, the most appropriate were then assigned for each of the highway segments studied. Figure 12 shows the WIM spectra on the California highway segments populated by the decision tree approach in the California Pavement Management System (PaveM) (Kim et al., 2023).

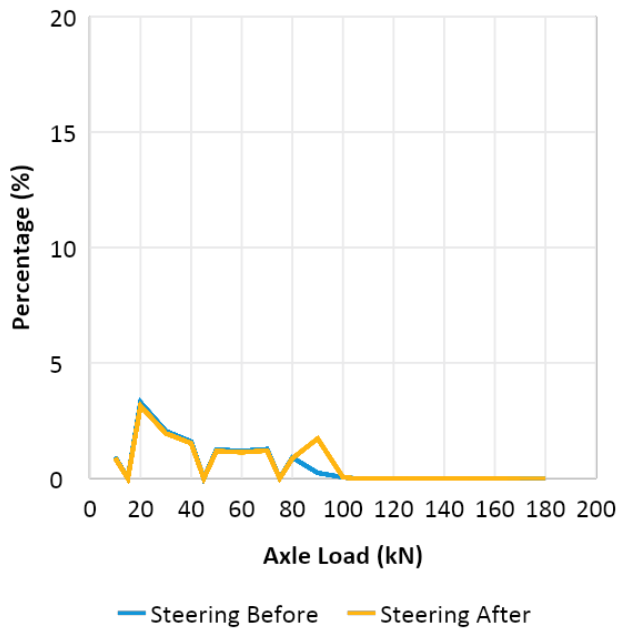
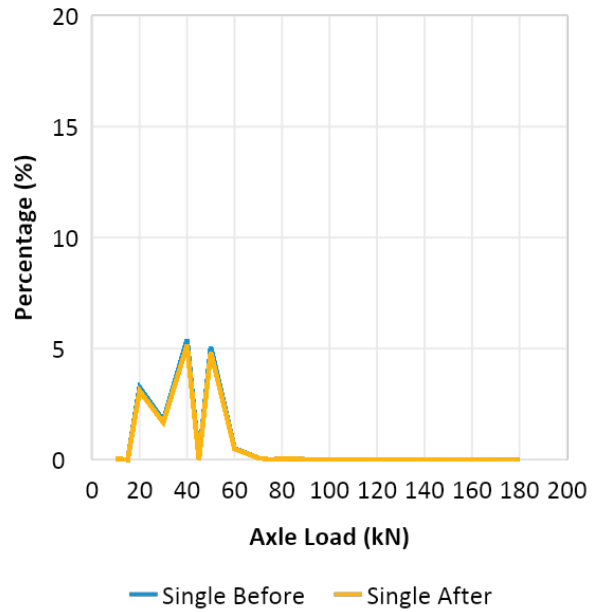
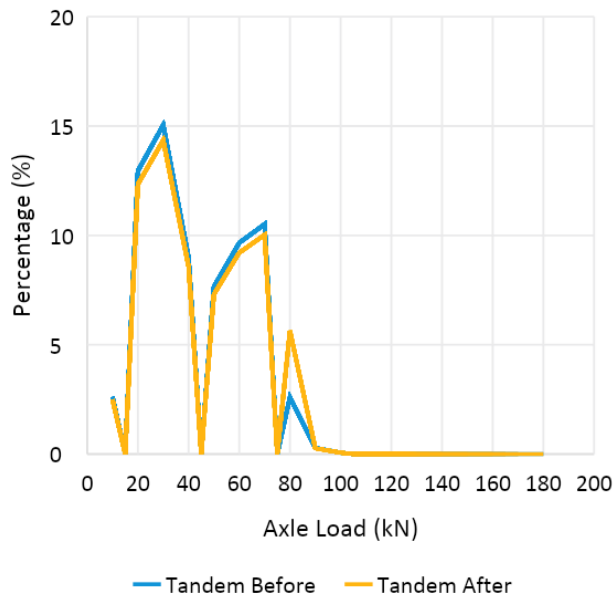
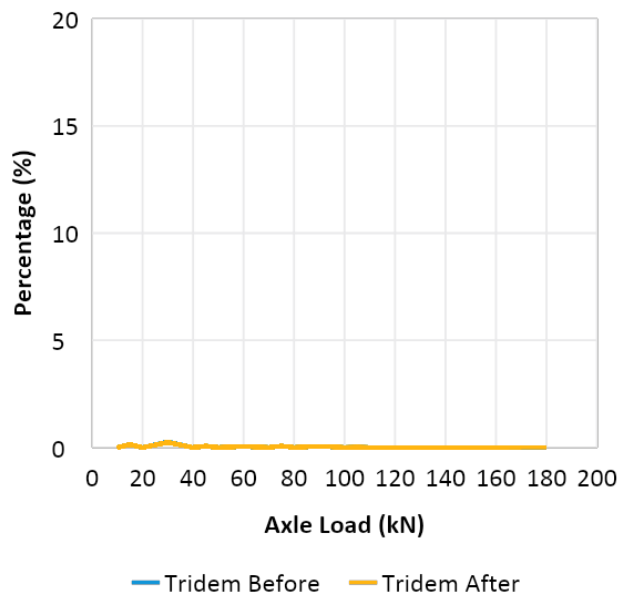
Figure 13. The load spectra per axle type for State Route 99 (Butte County, postmiles 32-43) before and after Camp Fire (the average from February to August 2019): (a) steering axle, (b) single axle, (c) tandem axle, (d) tridem axle

For the scenarios with wildfire hauling truck trips during each month from February to August 2019, the exiting steering, single, tandem, and tridem axle load spectra in the WIM Spectra 3 were modified to reflect the actual additional monthly truck trips by converting the additional monthly trips of two-, three-, four-, and five-axle trucks to the additional portions of steering, single, tandem, and tridem axles in each month of the active debris haul period. Figure 13 (a)-(d) shows the load spectra per axle type with and without the Camp Fire. As shown in the figures, the change in the axle load groups for each axle type was small from the wildfire debris haul when considered for a 20-year analysis period.

The largest change in the number of axles was approximately 9% in June 2019. The average change in the number of axles was 4% for the seven-month active debris haul period. This change in axle load spectra for the seven months over 20 years of analysis period was not significant enough to make a noticeable difference with and without wildfire debris haul truck trips. Based on this initial study, it was decided to use the before-fire WIM spectra for the highway sections with adjustments to other traffic parameters, as discussed below.
