Documentation of soil conditions at liquefaction and non-liquefaction sites from 1999 Chi-Chi (Taiwan) earthquake

Soil Dynamics and Earthquake Engineering, Vol. 24 (2004), pp 647-657

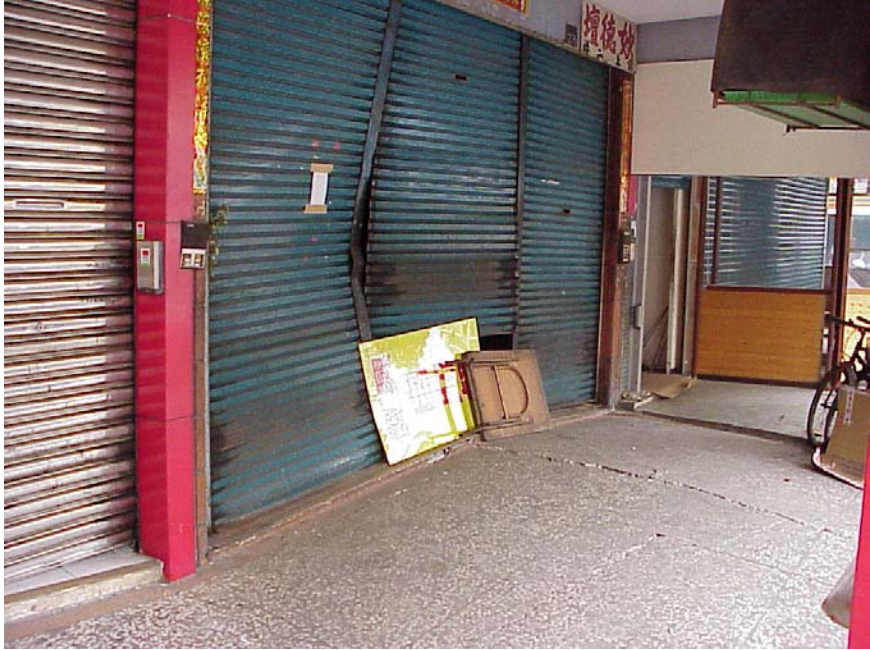
Fig. 2. Floating floor slab fractured by 25 cm settlement at walls/columns

Ground failure in Nantou from the Chi-Chi earthquake took on several forms. East of the Mao-Lo River, there are a number of cases of classic liquefaction involving free-field sites with sediment boils and ground subsidence. Lateral spreading occurred at many locations along the Mao-Lo River. West of the river, the city is relatively densely developed, and detailed mapping in this area provided locations where ground subsidence beneath buildings did and did not occur. Ground failure in this area generally did not occur at free-field sites, instead being localized around and beneath building foundations. A typical example is shown in Figure 2, which shows a single bay of a 4-story building with a distance between load-bearing walls of about 4.2 m. The walls and exterior columns are supported on spread footing foundations that settled approximately 25 cm, breaking the “floating” intermediate floor slab. Few sediment boils were observed west of the river.

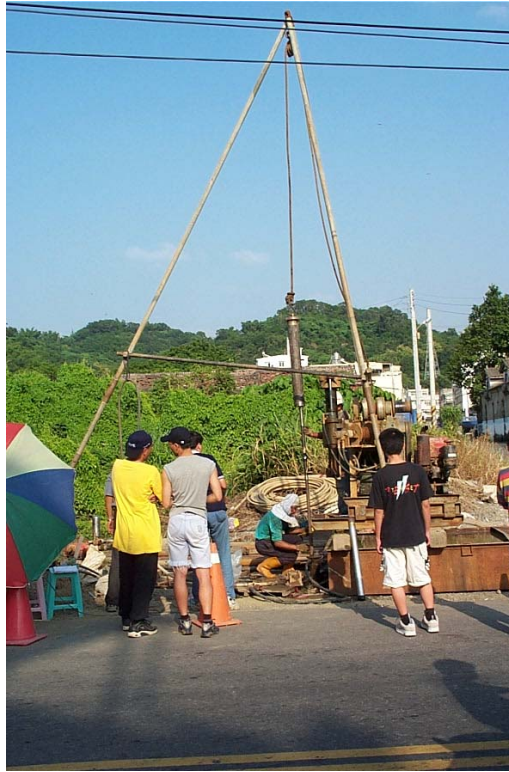
Fig. 5. Tripod supported drilled rig with a safety hammer for SPT

Most of the borings were limited to depths of 10-30 m. Drilling equipment consisted of a tripod-supported rotary wash rig. The drill bit used with the rig excavated a 12-cm-diameter borehole. A typical rig setup over a hole is shown in Figure 5. For SPT sampling, the percentage of the total theoretical energy delivered to the split-spoon sampler, or energy ratio, was controlled by following

procedures in ASTM D6066-98 and ASTM D1586. We used a safety hammer manufactured locally in Taiwan following the specifications of Kovacs [7]. A rope and cathead hammer lift and release mechanism was used with two turns of the rope around the cathead. A standard split spoon sampler was used (5 cm outside diameter) with no internal space for liners. Standard AW rod (i.e., outside diameter = 57.1 mm) was used to connect the split spoon sampler to the anvil, which was 9 cm in diameter. Based on these specifications, the energy transmitted to the sampler would be assumed to be 60% if no short-rod correction was applied.

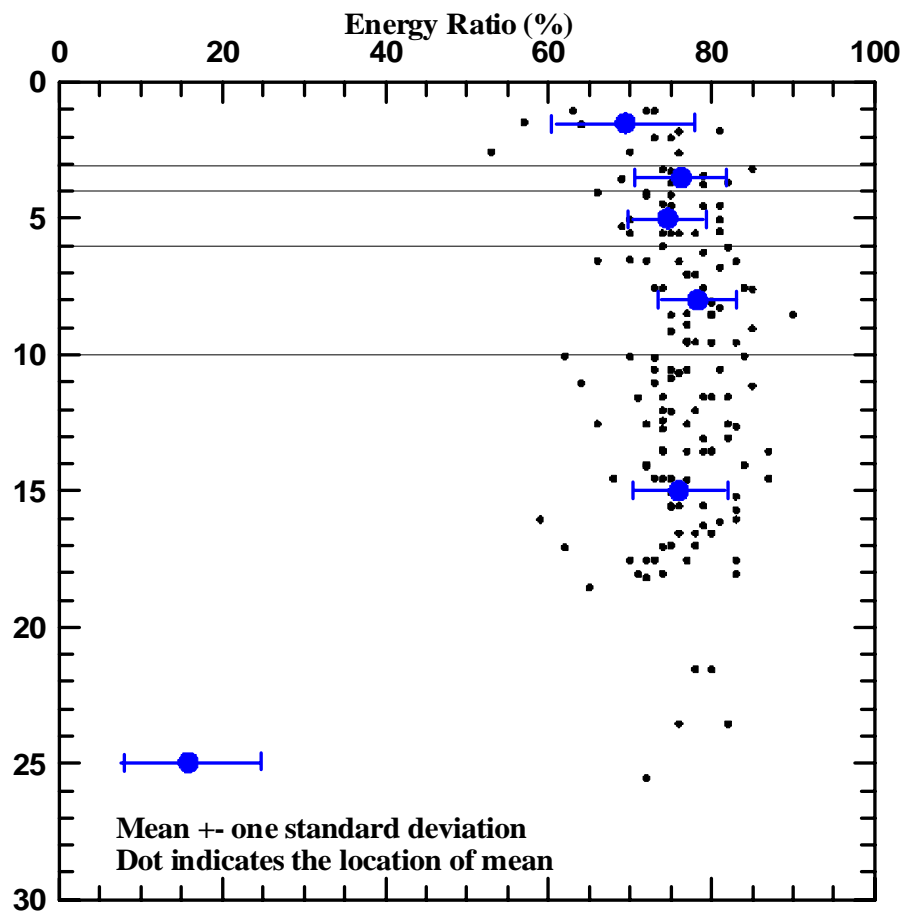
Fig. 6. Field energy ratio measurements during SPT testing

We attempted to measure the actual delivered energy for each blow of the safety hammer using a rod section instrumented with accelerometers and strain gages. However, early in the site exploration program, the accelerometers failed and hence many of the energy measurements are based only on strain gage data. Abou-Matar and Goble [8] have reported that significant errors can result from energy measurements based only on strain gauge data, especially when variable rod diameters are used. Although we used consistent rod sizes, it is nonetheless possible that our energy ratio data contains errors that could increase the dispersion of the measurements relative to what would have been obtained had both sensors operated properly. Nonetheless, the data as recorded is presented in Figure 6 to show the general trend of the results. Mean energy ratios (ER) of about 75% are observed for depths > 3 m, with a small reduction in ER at shallow depths (mean of 69% in upper 3 m). These energy ratios indicate greater hammer efficiencies than would generally be expected for the rope and pulley system at depth (75% vs. the recommendation of 60% by [9]). The short rod correction effect is also negligible in our data except within the upper 3 m.

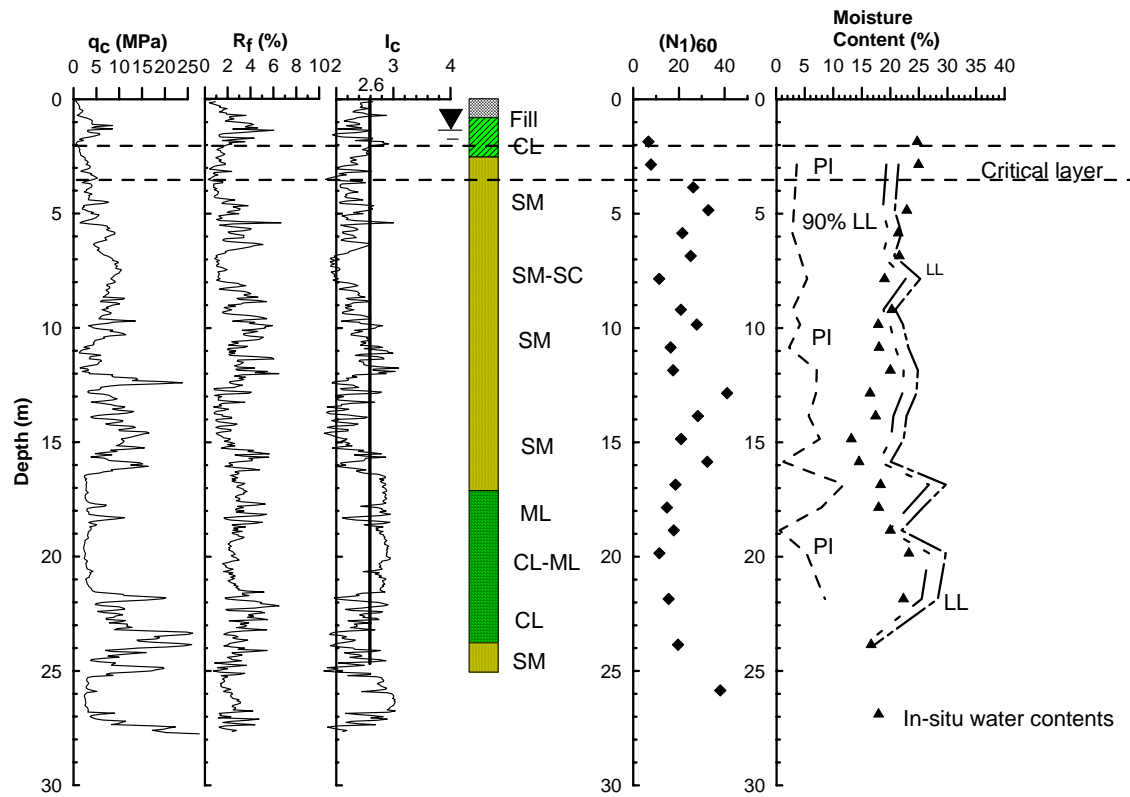
Fig. 7. Subsurface data for example site that experienced liquefaction (Wufeng Site C).

The example ground failure site is located in Wufeng (Site C), and consists of an open rice paddy that had clear evidence of liquefaction in the form of lateral spreading towards an adjacent creek, ground subsidence, and sediment boils. A synthesis of subsurface data for this site is shown in Figure 7. As shown on the right side of the figure, the soils in the upper 7 m of the site would be considered potentially susceptible to liquefaction on the basis of the liquid limit (LL) and water content (w_n) components of the widely used Chinese criteria, which state that the soil is susceptible if $LL < 35$ and $w_n/LL > 0.9$ [10, 11] (the clay fraction component of these criteria is neglected per the recommendations of [11] and observations from the Chi-Chi earthquake). Thus, given the water table depth of 1 m, the critical zone in the profile from the standpoint of liquefaction susceptibility is from 1 to 7 m. Within the 1-7 m depth range, the

critical zone from the standpoint of liquefaction triggering is identified based on careful study of CPT tip resistance and friction ratio as well as SPT penetration resistance. Based on these considerations, the critical zone for liquefaction triggering at this site is from about 2 to 3.5 m, and in this zone the SPT and CPT data indicate $(N_1)_{60} \approx 5$ blows/ft, $q_c \approx 2.6$ MPa, $R_f \approx 2.4$ %, and $I_c \approx 2.5$. These data can then be coupled with the cyclic stress ratio (CSR) for the site (approximately 0.6 in the critical layer) to show that the site plots well above liquefaction triggering threshold curves (e.g., Figure 8). Hence, the site performance is consistent with expected behavior. Finally, it should be noted that because there are many borings and CPTs at this and other lateral spread sites, the data can be used to formulate valuable case histories for empirical lateral spreading models [12, 13]. This work is ongoing.

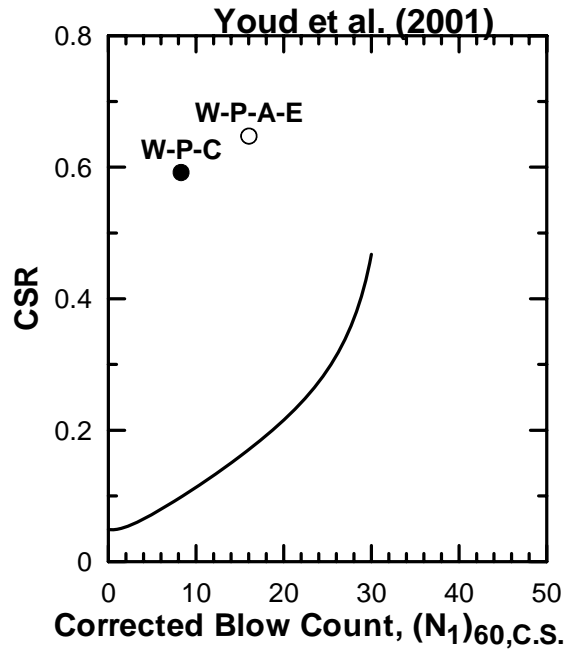
Fig. 8. SPT-based liquefaction triggering threshold curve of Youd et al. [9] along with data from a liquefaction site (W-P-C) and a non-ground failure site (W-P-A-E) in Wufeng. Both of these sites are susceptible to liquefaction on the basis of the modified Chinese criteria [10, 11]

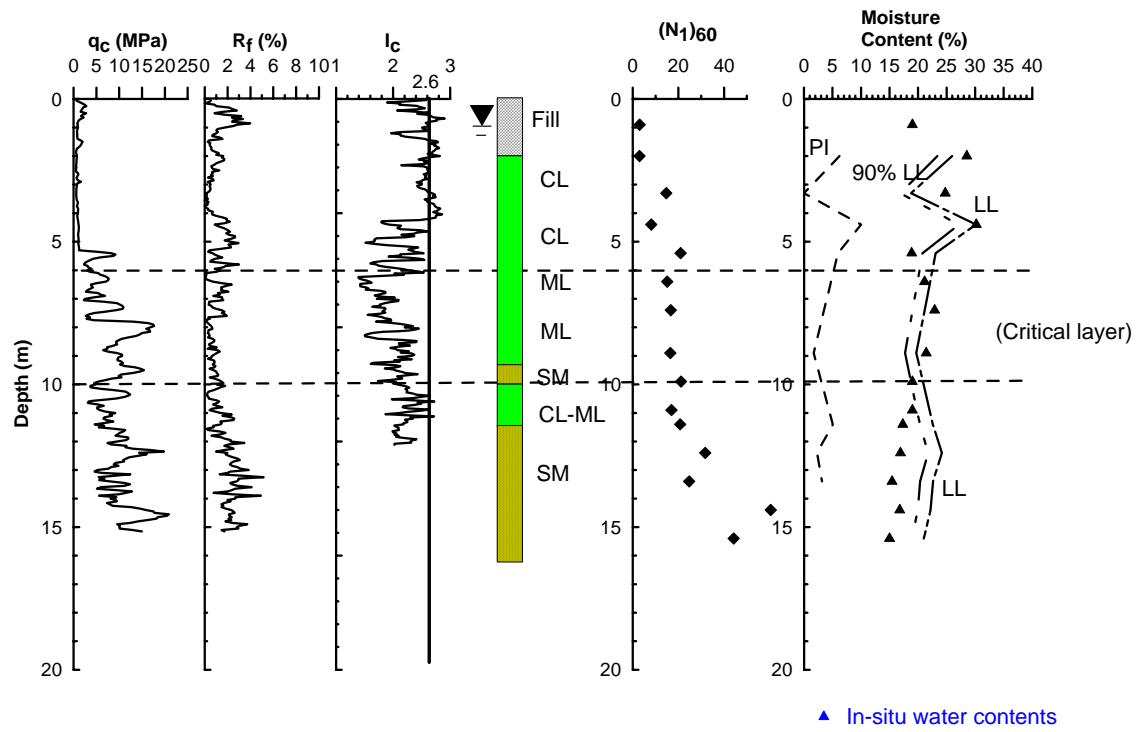
Fig. 10. Subsurface data for second example site that had no evidence of ground failure (Wufeng Site A-east)

The second example non-ground failure site is located in Wufeng (Site A-east), and consists of level ground with light wood frame houses. The area was surveyed within 2 weeks of the

earthquake, and no evidence of ground failure was observed. Figure 10 synthesizes the subsurface data for this site. As shown by the laboratory data on the right side of the figure, between the depths of 6 to 10 m, the soils pass the LL and w_n/LL components of the Chinese criteria, suggesting the material within this interval is susceptible to liquefaction. Within this zone the SPT and CPT data indicate $(N_1)_{60} \approx 15$ blows/ft, $q_c \approx 8.8$ MPa, $R_f \approx 0.9$ %, and $I_c \approx 1.9$. When coupled with the cyclic stress ratio (CSR) for the site (approximately 0.63 in the critical layer), the site plots well above liquefaction triggering threshold curves (e.g., Figure 8), suggesting that liquefaction would have been expected. Moreover, if the upper 6 m of the site is taken as a non-liquefiable crust and the liquefiable layer is taken as 4 m in thickness, liquefaction effects would be expected to be manifest at the surface based on the existing guidelines [14, 15], as shown in Figure 11. Thus, the performance of this site is inconsistent with existing models. While this subject remains under investigation, a working hypothesis based on preliminary analysis of this and other similar sites is that driving static shear stresses may be necessary for liquefaction effects to be manifested at the ground surface when the liquefaction involves high fines content, marginal plasticity soils.

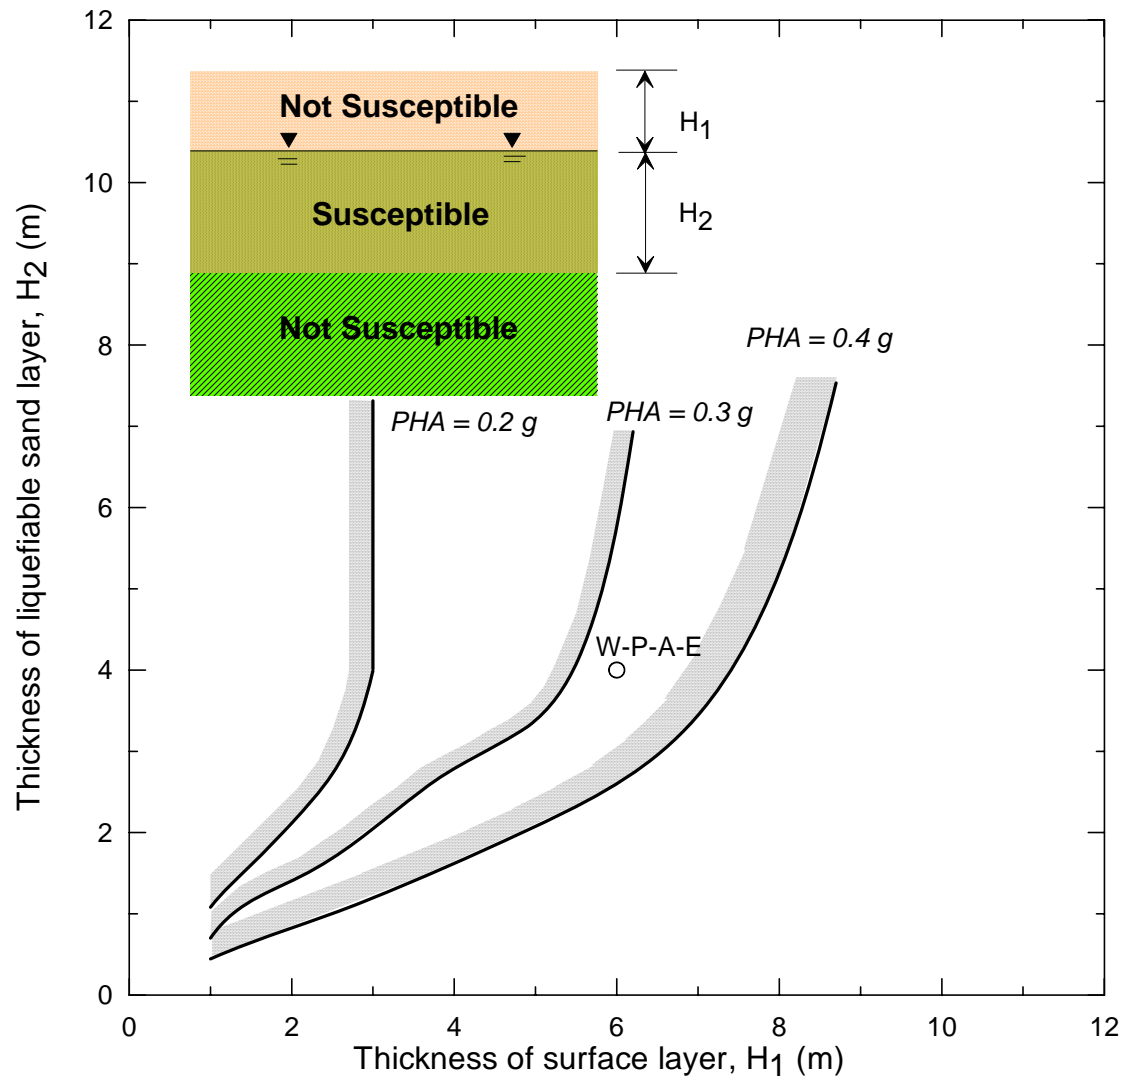
Fig. 11. Threshold curve for surface manifestation along with data point for Wufeng Site A – east.
